Fluvial Geomorphology Assessment

SUBJECT: Highway 401 Planning Study from Colborne to Brighton – Preliminary

Design and Class Environmental Assessment Study (GWP 4054-17-00)

- Four Structural Culverts Fluvial Geomorphology Assessment

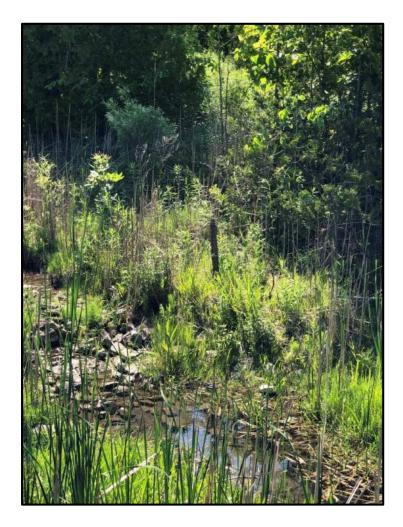
Culvert 21-471 Downstream - North of Highway 401

Looking upstream (South) from approximately 10m downstream of the culvert

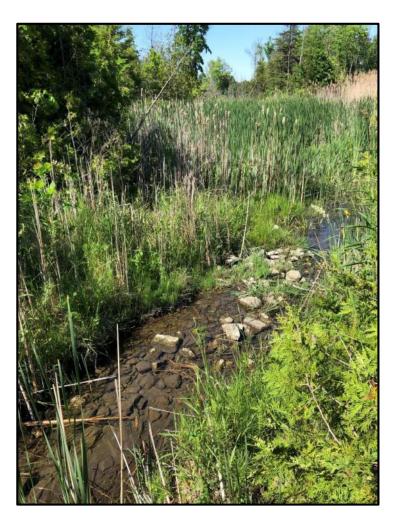
Looking downstream (North) from approximately 10m downstream of the culvert

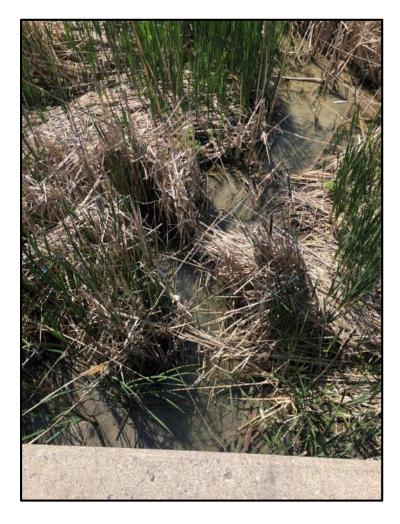
Culvert 21-471 Upstream – South of Highway 401

Looking upstream (South) from the culvert

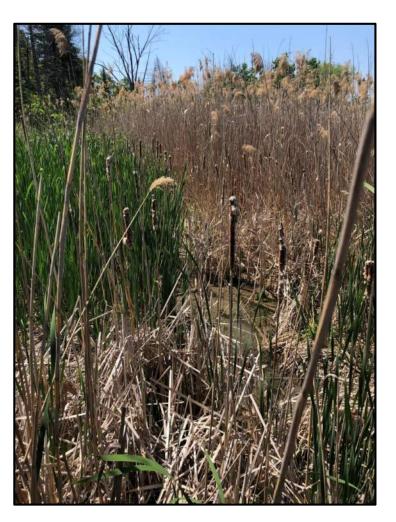
Looking upstream (South) from the culvert

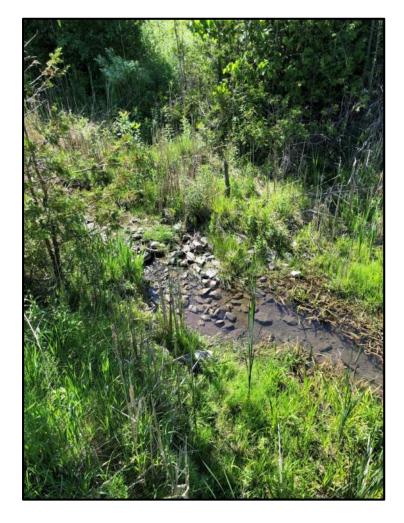
Culvert 21-472 Downstream – North of Highway 401

Looking upstream (South) from the culvert

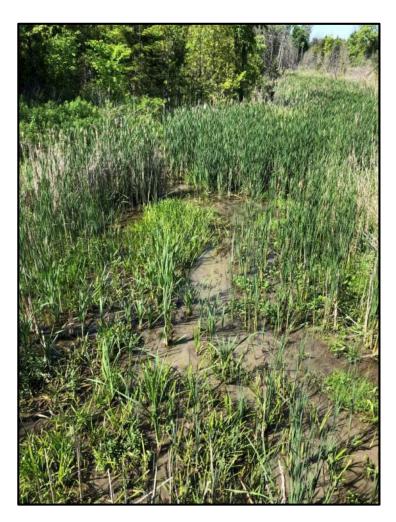
Looking downstream (North) from the culvert

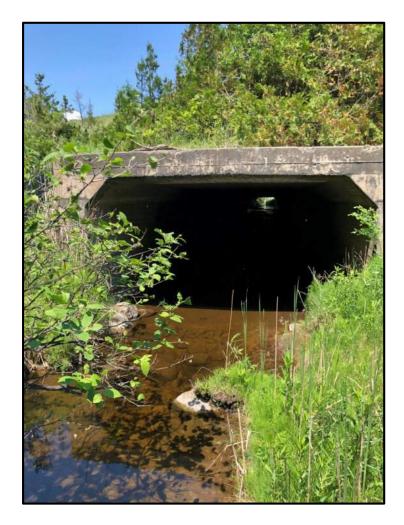
Culvert 21-472 Upstream – South of Highway 401

Looking downstream (North) from approximately 5m upstream of the culvert

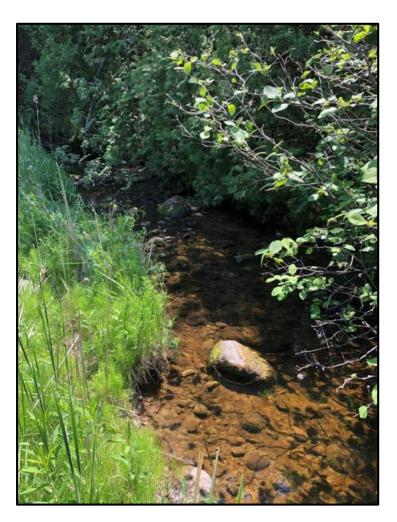
Looking upstream (South) from the culvert

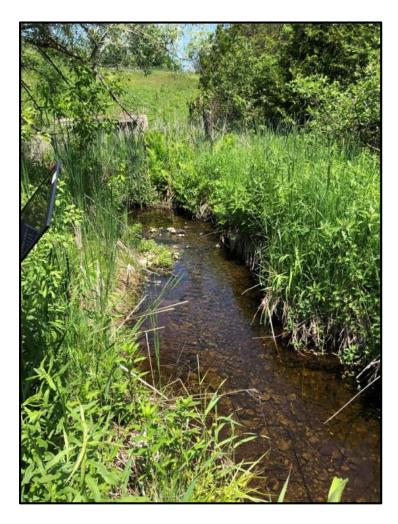
Culvert 21-473 Downstream - South of Highway 401

Looking upstream (North) from approximately 10m downstream of the culvert

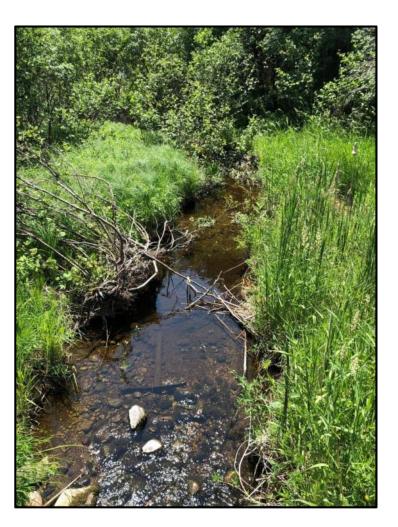
Looking downstream (South) from the culvert

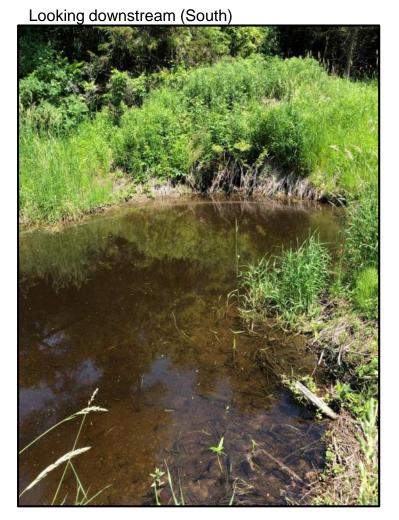
Culvert 21-473 Downstream – South of Highway 401

Looking downstream (South) from approximately 50m downstream of the culvert

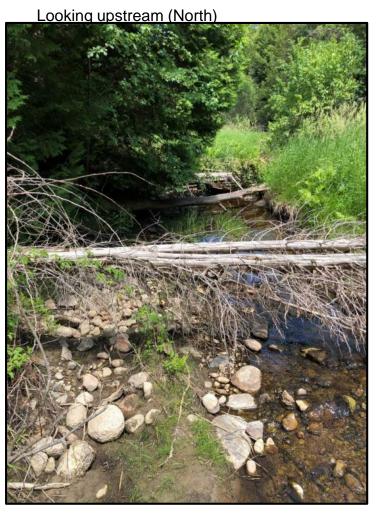
Looking upstream (North) from approximately 50m downstream of the culvert

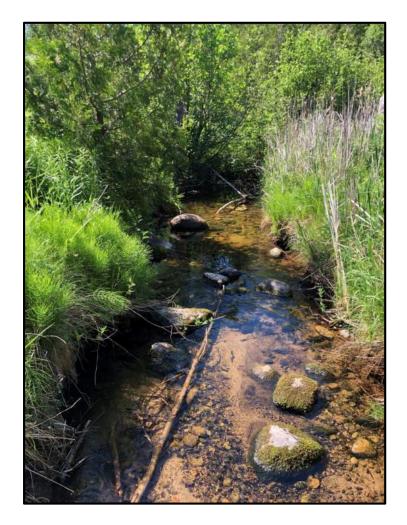
Culvert 21-473 Upstream – North of Highway 401

Looking downstream (South) from the culvert

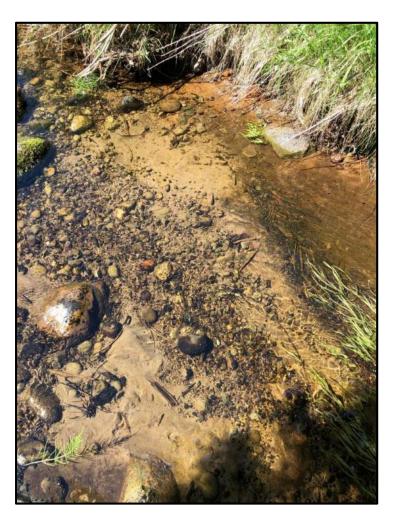
Looking downstream (South) from the culvert

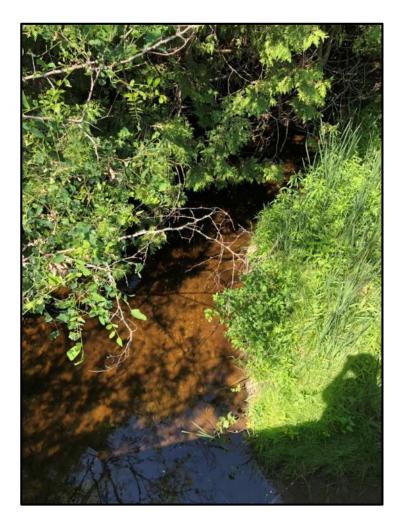
Culvert 21-474 Downstream - North of Highway 401

Looking downstream (North) from the culvert

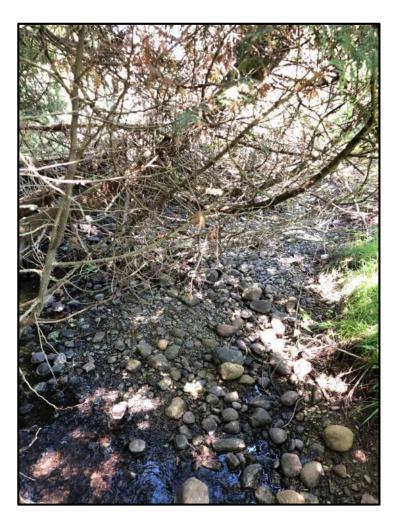
Looking downstream (North) from approximately 10m downstream of the culvert

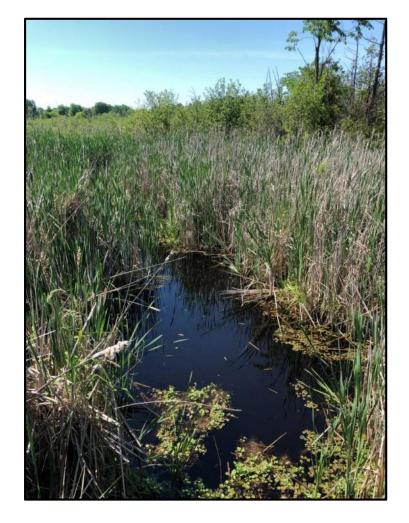
Culvert 21-474 Upstream – South of Highway 401

Looking upstream (South) from the culvert

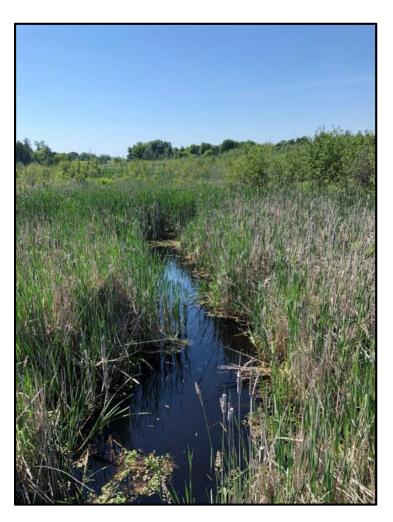
Looking upstream (South) from the culvert

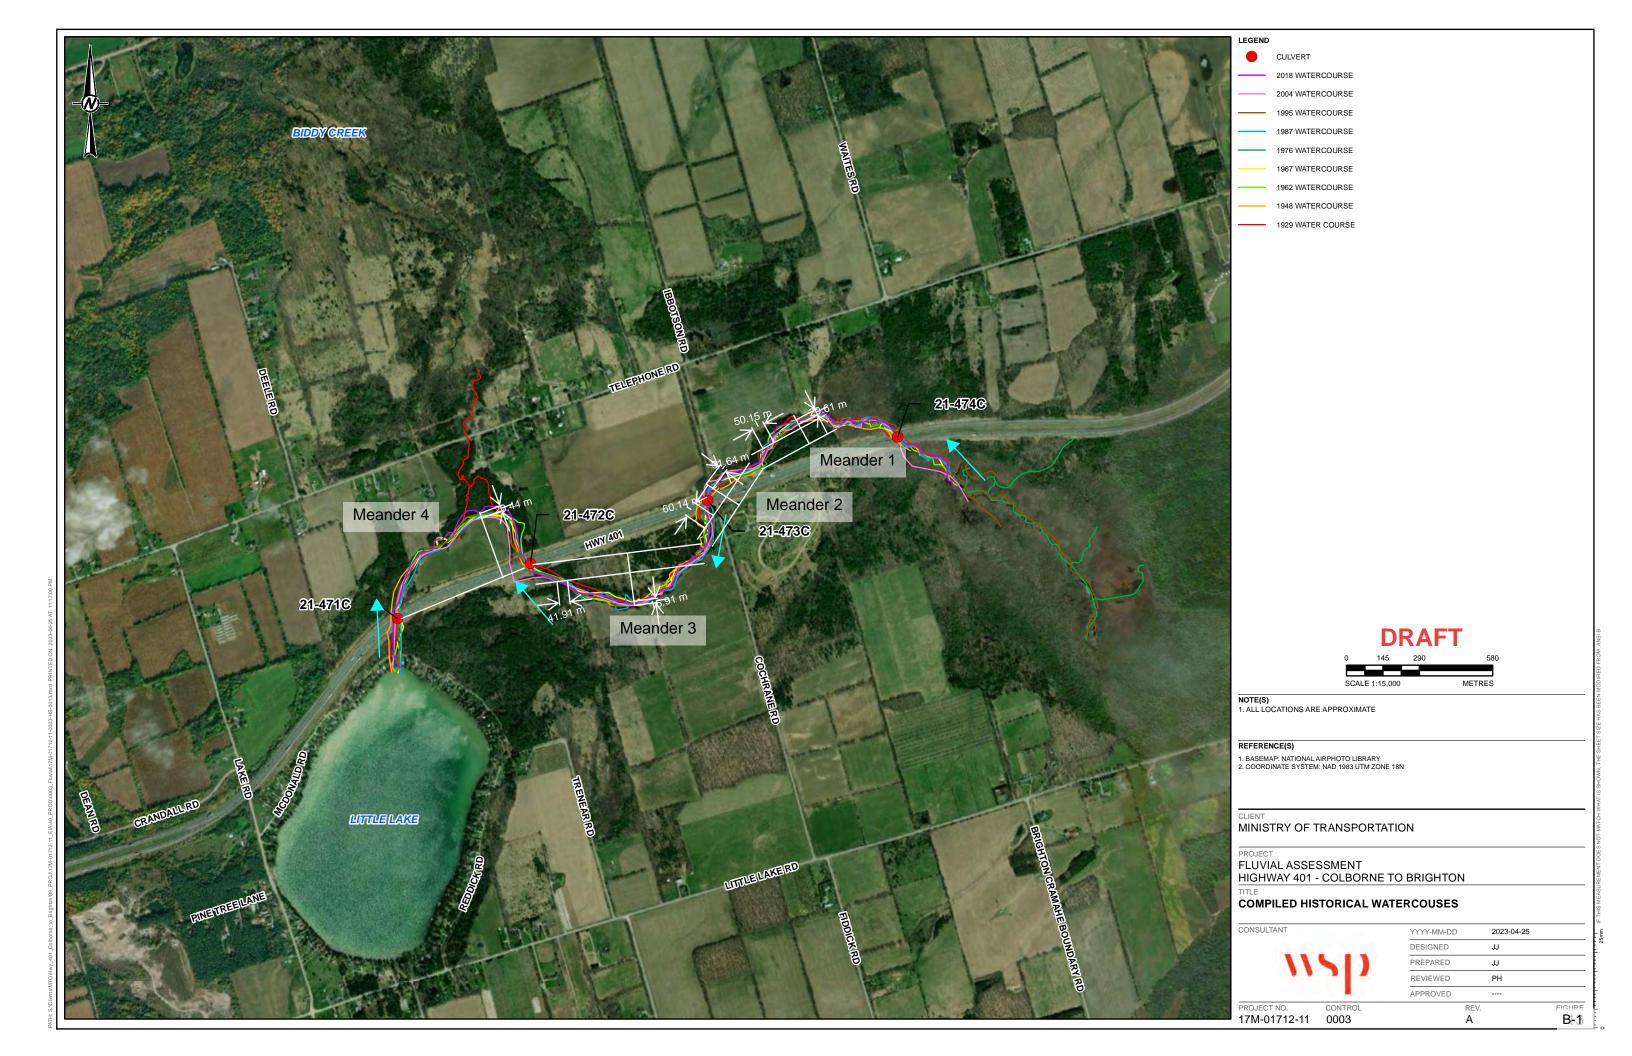
As depicted on **Figure B-1** in **Appendix B** the lateral migration (extension) values ranged from approximately 17 m to 32 m and the down-valley migration (translation) values ranged from approximately 42 m to 60 m, with an overall average of 35 m. Based on this assessment the 100-year extension / translational erosion rate for this watercourse at these four structural culverts is 39 m (based on the average / timeframe; 35 m / 89 years times 100 years).

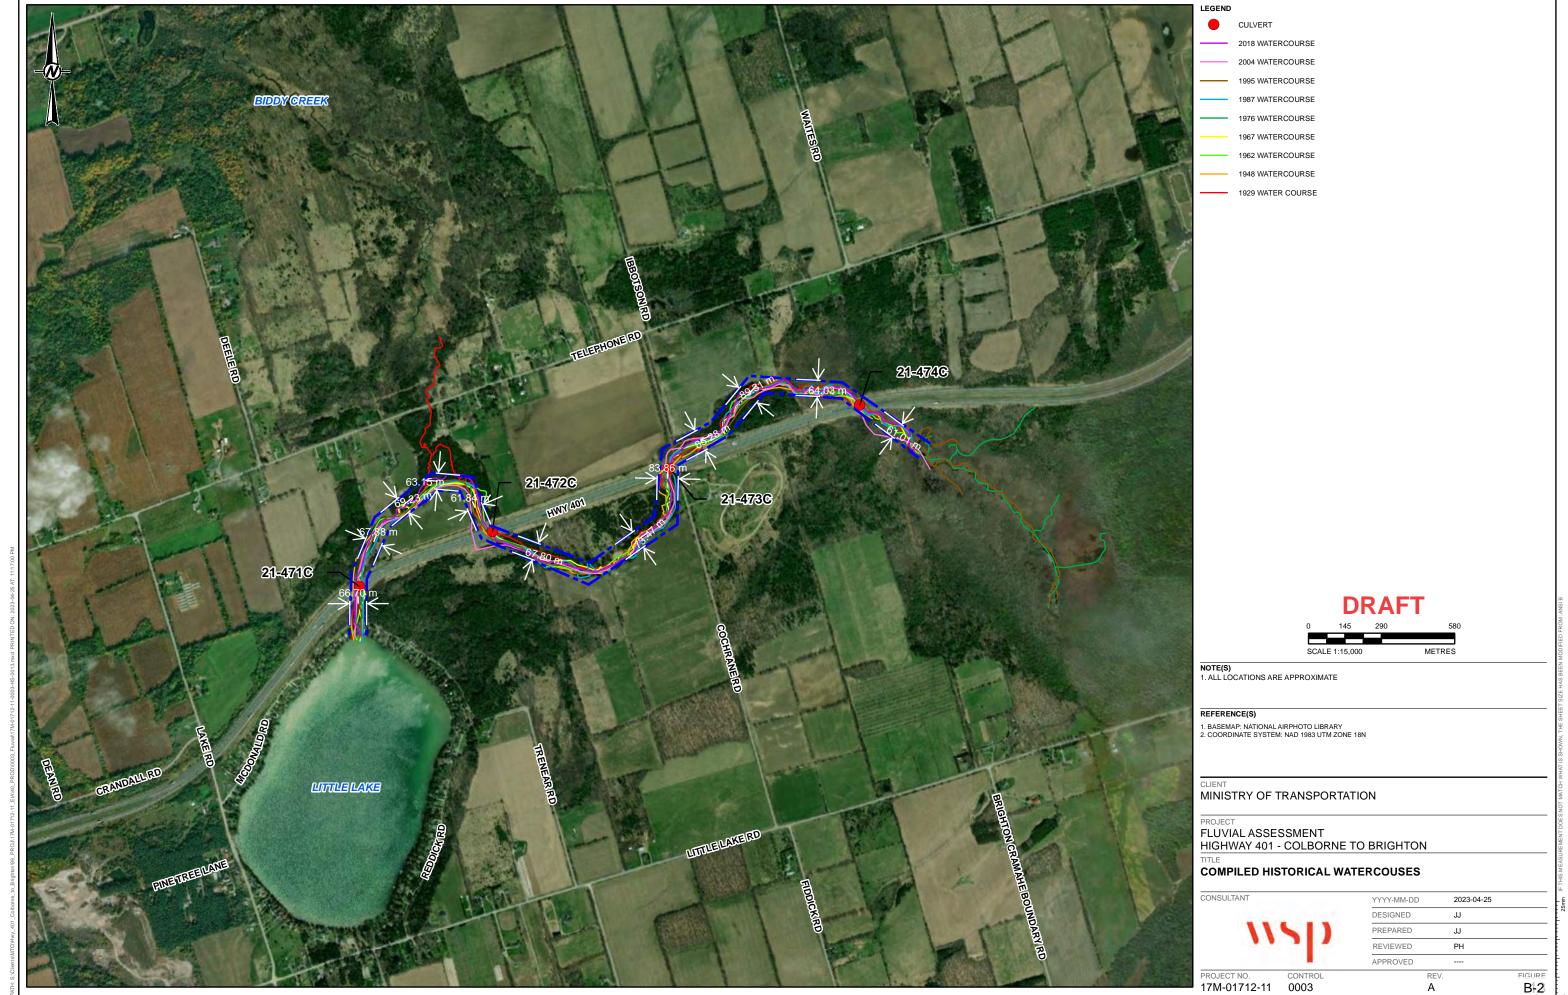
To complete the meander belt assessment WSP compiled the aerial imagery (1929, 1948, 1962, 1967, 1987, 2004 and 2018; an 89-year timespan) onto one figure for comparison. WSP outlined the meander belt and the meander axis on **Figure B-2** based on Parish Geomorphic (2004). This figure is provided in **Appendix B**. The following are the assumptions and limitations associated with this method:

Next WSP used the Parish Geomorphic (2004) equation for when no change in hydrology is anticipated, and the meander belt is greater then 50 metres to calculate the final belt width (Procedure 2). From the compiled figure WSP estimated the average meander belt width of 71 m, with the exclusion of some outliers. From the maximum field bankfull widths range of 1.8 m to 7 m (measure as a part of this investigation and the Fish and Fish Habitat Existing Conditions (WSP, 2021)) WSP calculated an average field bankfull width of 4.4 m. No shift in the belt axis was observed from the historical aerial assessment.

As such Final Belt Width = (71 m + 4.4 m)*1.10 + 0 = 75 m
