APPENDIX S

Erosion and Sedimentation Overview Risk Assessment

- **SUBJECT:** Highway 401 Planning Study from Colborne to Brighton Preliminary Design and Class Environmental Assessment Study (GWP 4054-17-00) – Erosion and Sedimentation Overview Risk Assessment
- **DATE:** August 30, 2023

PROJECT NO.: 17M-01712-11

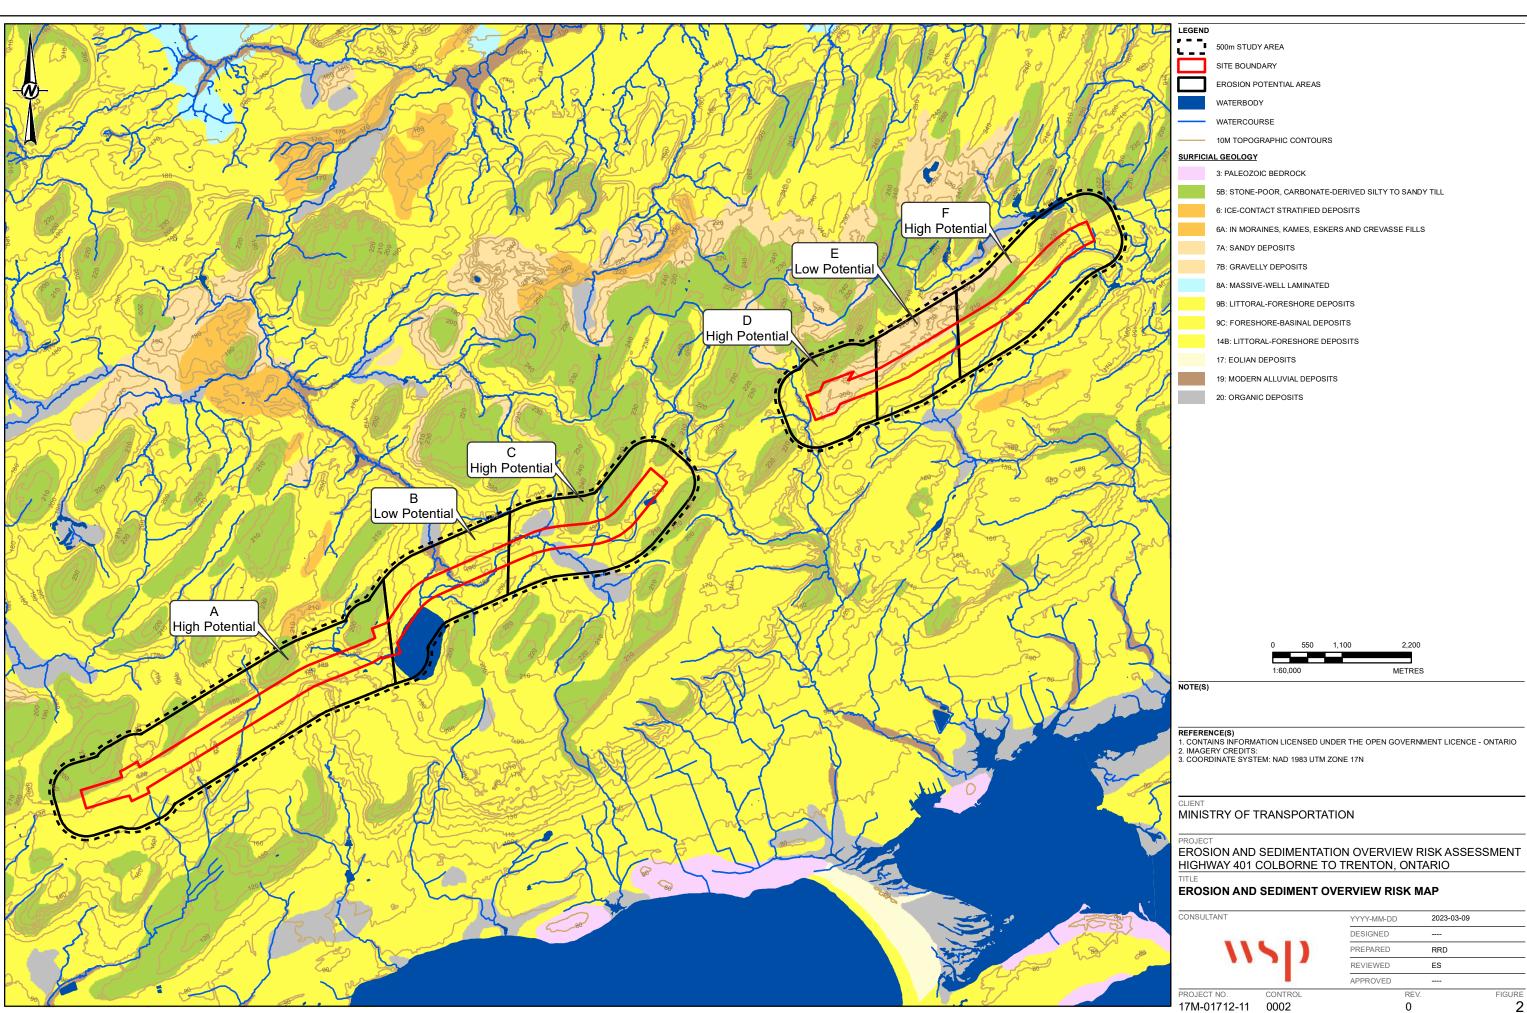
YYYY-MM-DD	2023-03-09	
DESIGNED		
PREPARED	RRD	
REVIEWED	ES	
APPROVED		
F	REV.	FIGURE
()	2

To complete the erosion and sedimentation risk assessment for the site WSP prepared attached **Figures 2 to 2.6**, which includes topographic contours, natural features and surficial geology. WSP divided the site into six (6) polygons (lettered A through F) of similar characteristics including geology, topography and natural features.

Each polygon was assessed based on the following MTO's (2015) Hierarchy of Soil Erodibility (**Tables 5.1**), which classifies various soil types (surficial geology mapping) as low, medium or high soil erodibility and MTO's (2015) Erosion Potential Associated with Slope Length, Slope Gradient and Slope Erodibility Rating (**Table 5.2**), which defines the erosion potential associated with the various polygons based on the soil erodibility from **Table 5.1** and the slope gradient and length (approximated based on the topography of the polygons). The results of the assessment are provided in **Table 1** and are shown on attached **Figures 2 to 2.6**.

F: +1 519 743-8778 wsp.com There are many natural features areas in the study area, including multiple watercourses, waterbodies and a number of wetlands, including Provincially Significant Wetlands. Natural features are shown on attached **Figures 2 to 2.6**.

Topographic contours across the study area range from approximately 160 m above mean sea level (AMSL) to 230 m AMSL. Topographic contours for the area are shown on attached **Figures 2 to 2.6**. Drainage is anticipated to be directed to local road side ditches or storm sewers which flow south into Lake Ontario.

A glaciofluvial deposit (gravel) is located along the eastern section of the alignment. Additionally the are organic deposits (peat, muck, marl) and modern alluvial deposits (clay, silt, sand, gravel, may contain organic remains) along some of the watercourses/wetland features. Surficial geology is shown on attached **Figures 2 to 2.6**.

Polygons were found to have high to low erosion potential. Polygons are considered to have high potential for consequences given the numerous waterbodies, watercourse and wetlands, including Provincially Significant Wetlands in the polygons. The anticipated high potential risk is considered manageable through the implementation of a proper erosion and sediment control plan, utilizing erosion and sediment control Best Management Practices (BMPs).

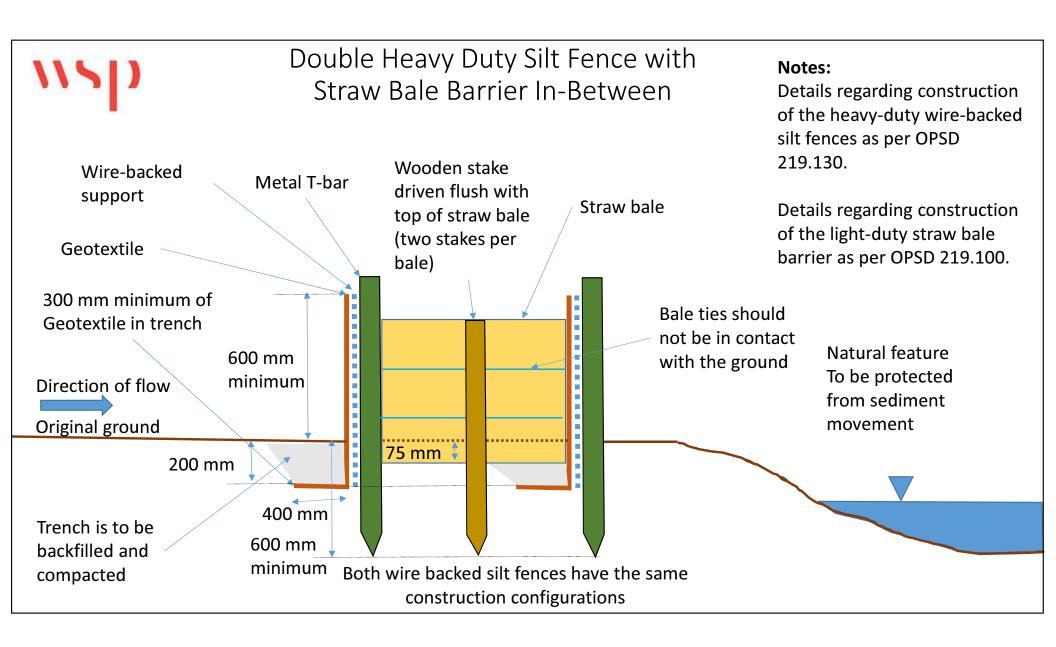
DIAGRAM OF A DOUBLE HEAVY DUTY SILT FENCE WITH STRAW BALES IN BETWEEN

- 6 OPSD 219.150 Sandbag Barrier
- 7 OPSD 219.160 Fibre Roll Grade Breaks
- 8 WSP has prepared a diagram for a double-heavy duty row of silt fence with straw bales in between. This installation is recommended to be used where a high level of perimeter sediment control protection is required adjacent to an environmentally sensitive feature, such as a watercourse, riparian zone, or wetland. It is also recommended at the base of slopes, because this silt fence configuration is more sturdy and robust as compared to a single silt fence installation. A diagram of this BMP is provided in Attachment A. This BMP is recommended to be used as a perimeter sediment control in the following situations:

- a To protect all watercourses deemed as fish habitat;
- b To protect all designated wetland areas;
- c To protect adjacent woodlots, valley lands, meadows, agricultural fields, and private properties, where the slope from the work site is downward towards such areas (for slopes greater than 10 percent, which are also more than 10 metres long, and / or more than two metres high relative to the site perimeter);
- d Around soil stockpiles, if soil is to be stockpiled at the work site perimeter; and
- e This BMP must be carefully designed to also include gaps with check dams and sediment basins, where concentrated flow of water leaves the work site.
